ADJUSTMENT OF THE VAC-U-TORQ CLUTCH BRAKE

ADJUSTMENT OF CLUTCH

ADJUSTMENT OF THE BRAKE

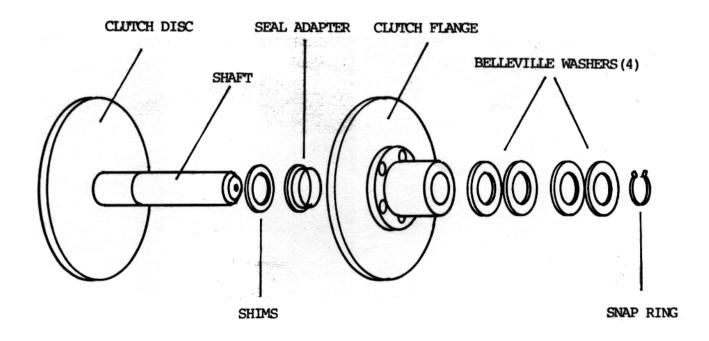
STEP 1: REMOVAL OF SNAP RING- WITH A HAMMER AND SCREWDRIVER POUND THE SNAP RING OUT OF ITS GROOVE. REMOVE. STEP 2: REMOVE THE (4) BELLEVILLE WASHERS.

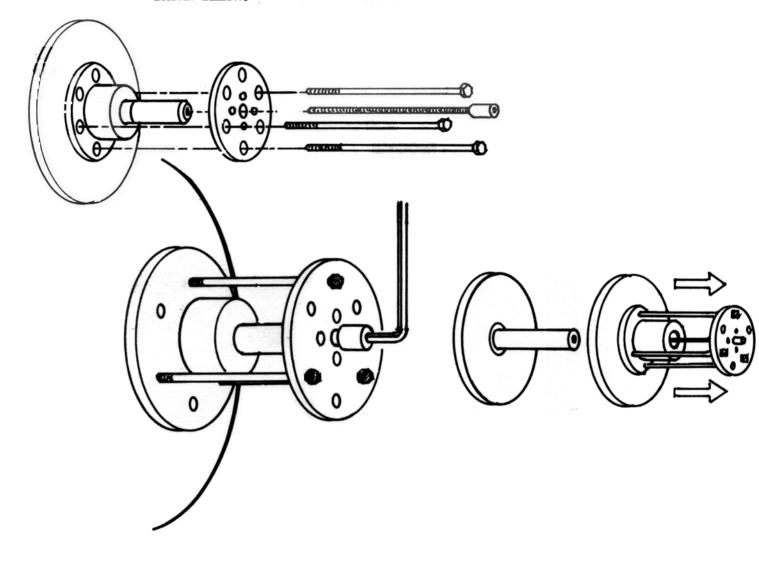
STEP 3: REMOVAL OF THE CLUTCH FLANGE- USING THE TOOL PROVIDED SCREW THE (3) BOLTS TIGHT INTO THE HOLES IN THE INPUT HUB AS SHOWN BELOW.

BY ROTATING THE CENTER BOLT CLOCKWISE THE CLUTCH FLANGE SHOULD NOW SLIDE OFF THE SHAFT. REMOVE IT AND DO NOT DROP IT.

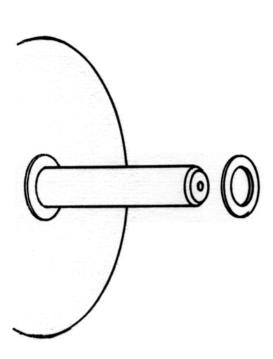
STEP 6: ONCE THE SEAL ADAPTER IS REMOVED THE SHIMS WILL BE EXPOSED. SLIDE OUT THE FIRST SHIM. DO NOT REMOVE MORE THAN ONE. THIS IS A 0.003" ADJUSTMENT.

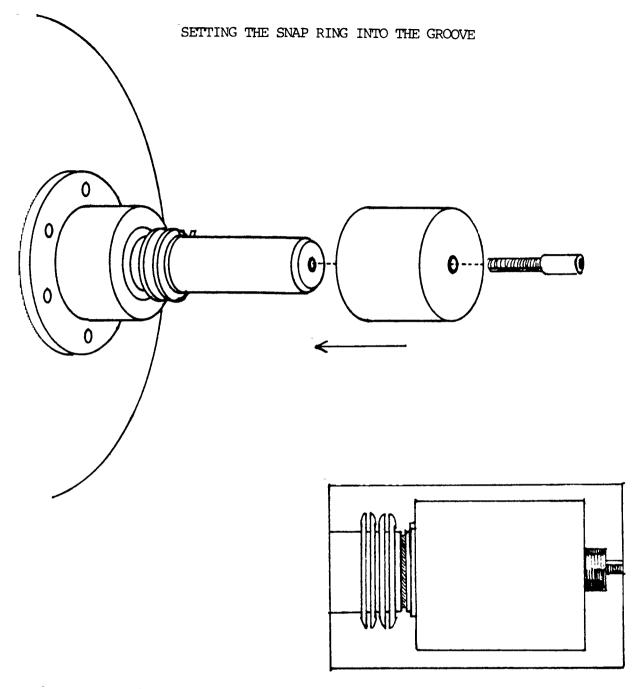
STEP 10: SLIDE A <u>NEW</u> SNAP RING ONTO THE SHAFT AS FAR AS IT WILL GO BY HAND. SNAP RINGS ARE PROVIDED. NEVER USE AN OLD ONE.

STEP 11: USING THE SNAP RING TOOL PROVIDED, SLIDE IT ONTO THE SHAFT AGAINST THE SNAP RING. TIGHTEN THE ALLEN BOLT CLOCKWISE SLOWLY UNTIL YOU HEAR A "SNAP". STOP. THIS SOUND IS THE SNAP RING SEATING INTO THE SNAP RING GROOVE. THE CLUTCH HAS NOW BEEN ADJUSTED 0.003". IF THIS HAD BEEN THE BRAKE SIDE NOW WOULD BE THE TIME TO TIGHTEN THE ALLEN SET SCREW.

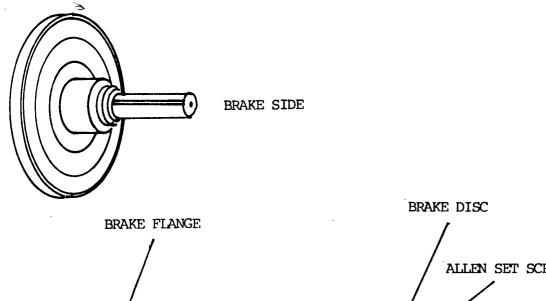
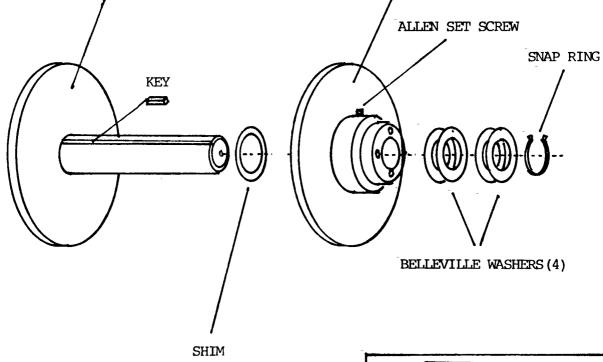
STEP 1: WITH A HAMMER AND A SCREWDRIVER

POUND THE SNAP RING OUT OF

ITS GROOVE. REMOVE.

STEP 2: REMOVE THE (4) BELLEVILLE WASHERS.

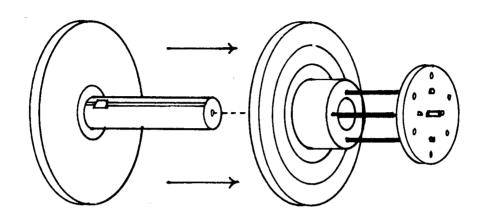
STEP 4: REMOVAL OF THE DISC- USING THE TOOL PROVIDED TIGHTEN THE (4) BOLTS PROVIDED INTO THE HOLES IN THE DISC AS SHOWN BELOW.

ROTATING THE CENTER BOLT CLOCKWISE, THE DISC SHOULD SLIDE OFF THE SHAFT. REMOVE.

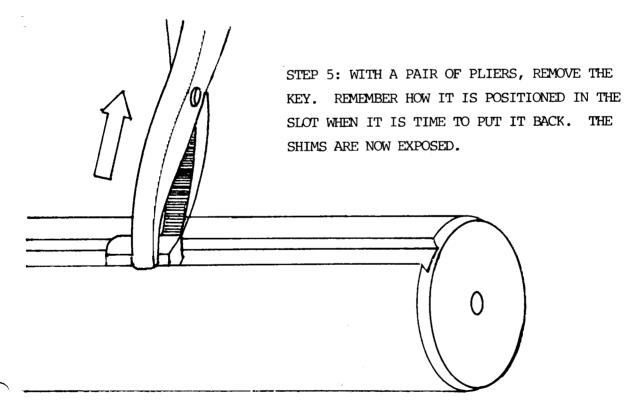
STEP 6: SLIDE OUT THE FIRST SHIM AND REMOVE. DO NOT REMOVE MORE THAN ONE. THIS IS A 0.003" ADJUSTMENT.

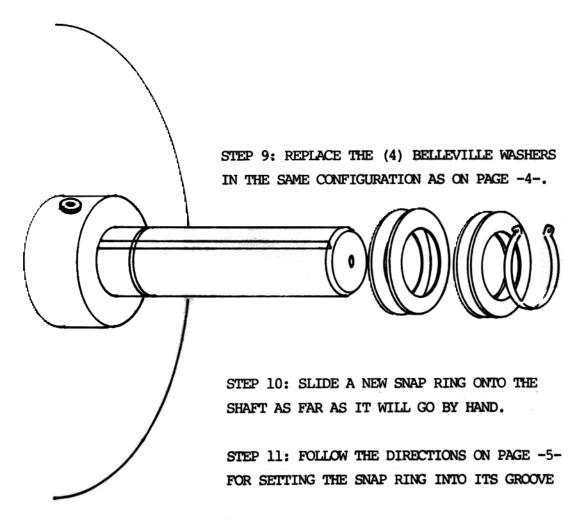
STEP 8: SLIDE THE BRAKE DISC ONTO THE SHAFT OVER THE KEY
AS FAR AS IT WILL GO BY HAND. DO NOT TIGHTEN THE ALLEN SET
SCREW YET !!!

STEP 12: TIGHTEN THE ALLEN SET SCREW NOW !!
